**ASSESSMENT OF PREMATURE WOOD UTILITY POLE FAILURE IN BUTAMBALA
DISTRICT - UGANDA.**

**A RESEARCH REPORT SUBMITTED TO THE DEPARTMENT OF FORESTRY
BIODIVERSITY AND TOURISM IN PARTIAL FULFILMENT OF THE REQUIREMENTS
FOR THE AWARD OF A BACHELOR'S DEGREE OF SCIENCE IN FORESTRY OF
MAKERERE UNIVERSITY**

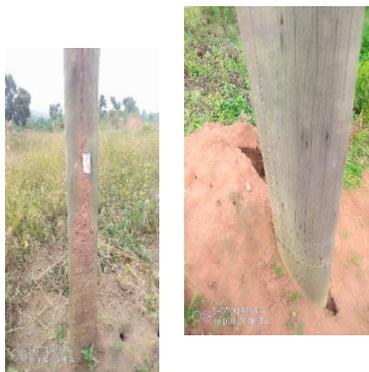
Assessment of wood utility pole failure on the basis of termite infestation, indicated that, Out of the 90 respondent that were interviewed, 65.6% said wood utility poles deterioration is as a result of termite attack as shown in figure 1, 26.7% said termites do not attack treated poles while 7.8% were not sure as shown in the frequency **table 5**.

Figure 3: Wood utility pole in service infested by termites.

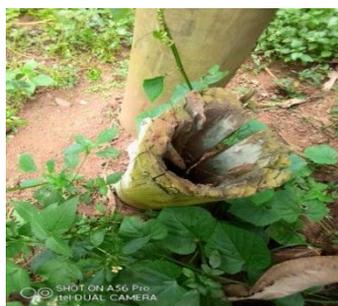
Figure 4: Utility pole that was replaced due to a hollow inside caused by decay

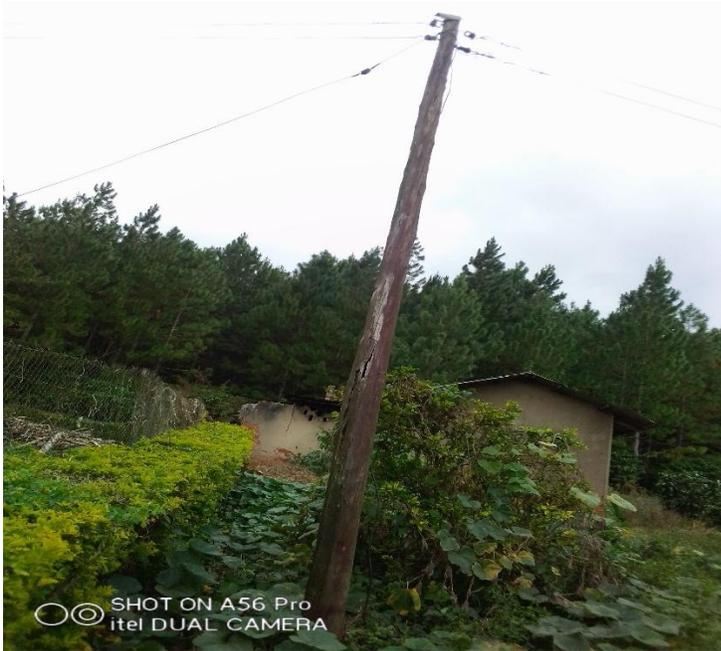
Figure 5: Aged utility pole in service.

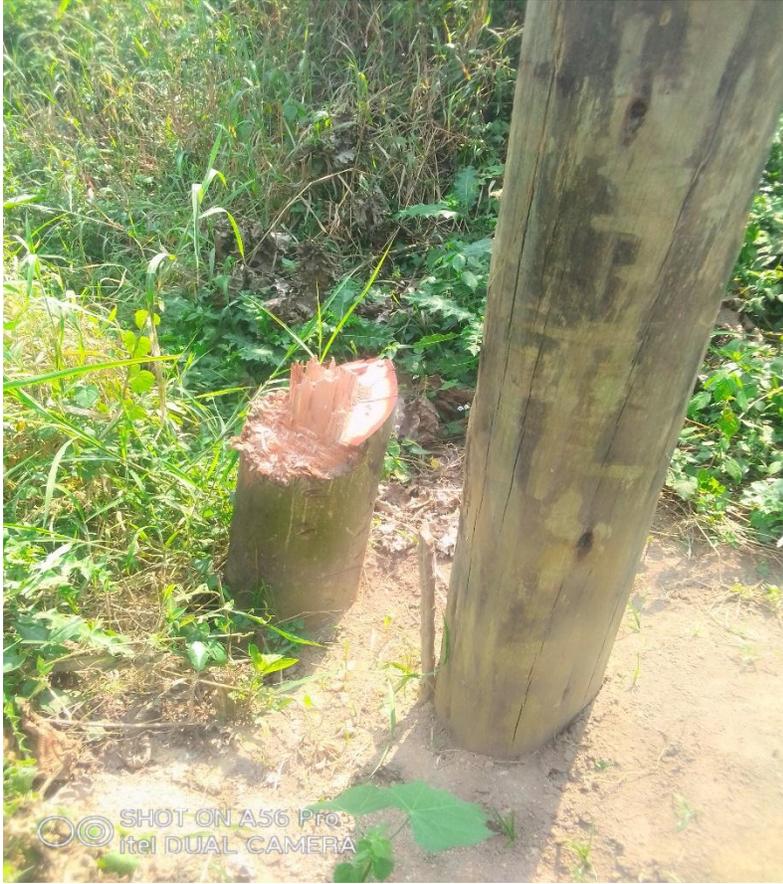
From the frequency table 10, 26 of the respondents said it is true that wood utility poles prematurely fail as a result of splitting and cracking and aging contributes approximately 29% to utility pole failure that occurs in the region as indicated by the utility pole in figure 4, 50% of the respondent said premature failure of wood utility poles caused by other factor except splits and cracks while 21% of the respondent had no idea about this.

Figure 6: CCA treated pole with simple splits beside is the other CCA treated pole cut by locals as a result of power demonstration storage.

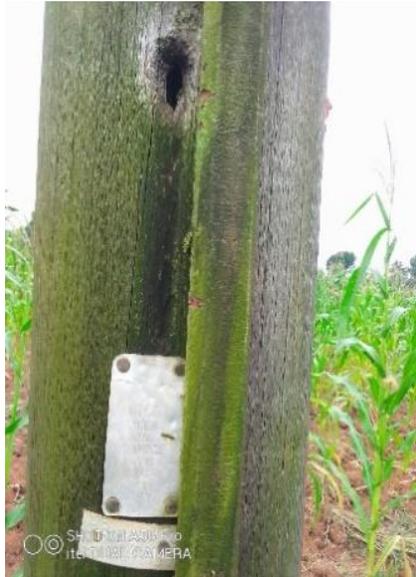
From figure 5 shows that wood pecker bird cause wood utility deterioration and this contributes only 73% to premature wood utility failure as reported by the respondent, 13 of the respondents said wood peckers have negligible effect on utility poles as indicated by approximately 14% of the respondents, while only 12% of the respondent were less informed about this as shown in table 11.

Figure 7: A hole drilled in a wood utility pole by wood pecker birds.

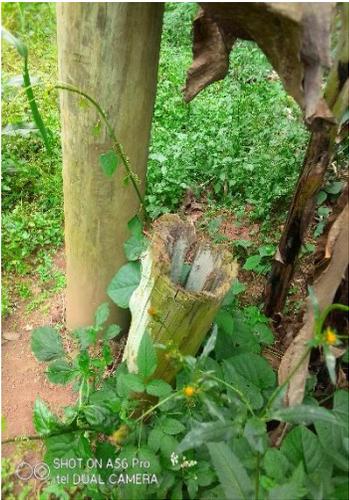
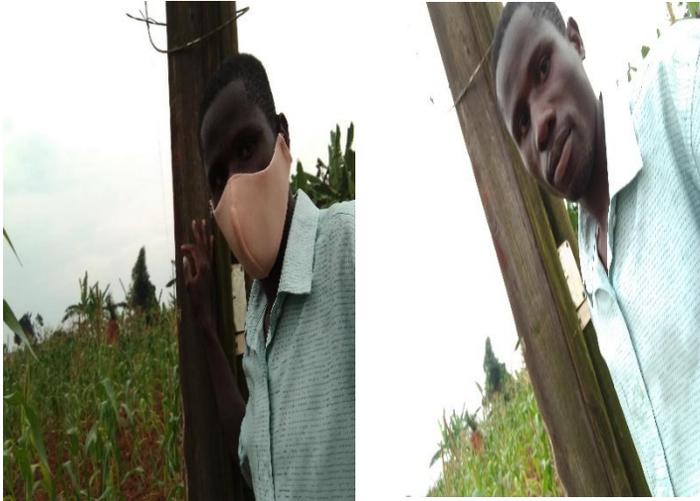
Figure 8: Agricultural activities carried out near utility poles

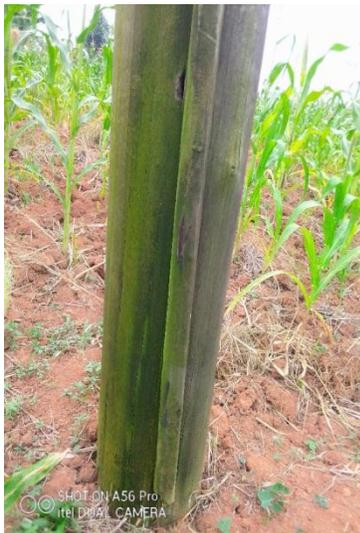
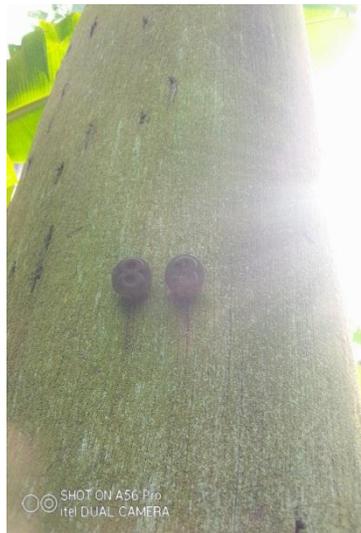
Figure 9: creosote treated poles which has stayed for over 30 years but still in good serving condition.

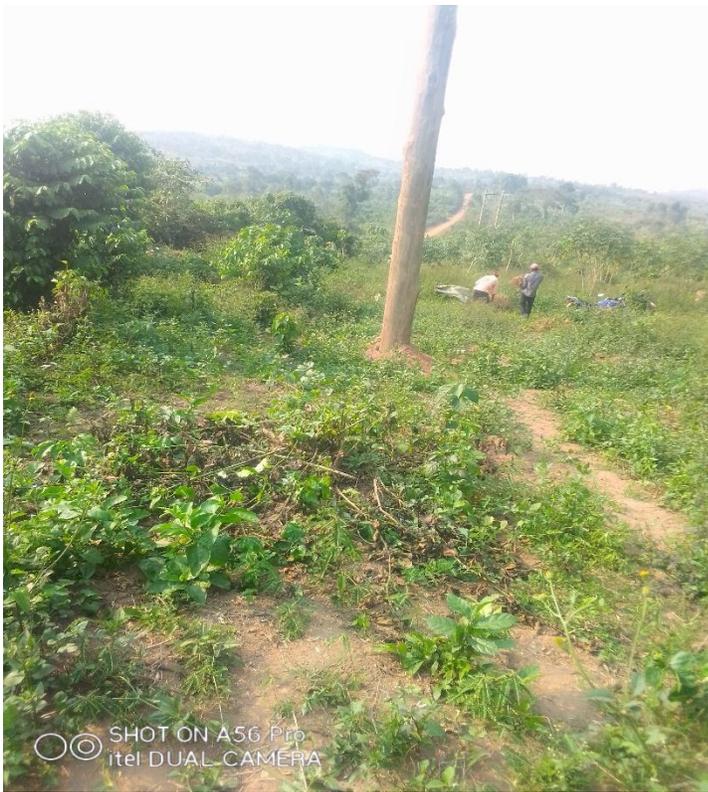
Figure 10: CCA treated poles in good serving condition.
