COLLEGE OF ENGINEERING, DESIGN, ART AND TECHNOLOGY

CIV 4200: CIVIL ENGINEERING PROJECT II

**DIAGNOSTICS FOR THE DEVELOPMENT AND APPLICATION OF AN URBAN
WATER FLOW DIAGRAM IN SMALL TOWNS; A CASE STUDY OF MPIGI
TOWN COUNCIL.**

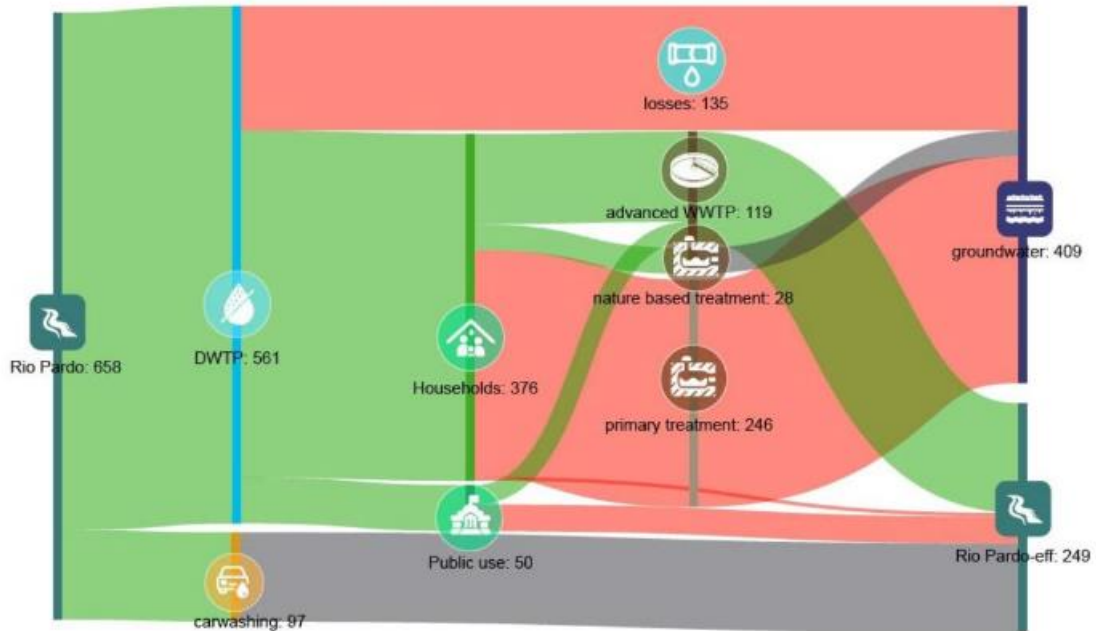
Figure 2-1: Quantitative visualization of the uWFD

The quantitative analysis of water use from the uWFD provides evidence to answer the question, of whether the amount of water used by each water user is “appropriate” or “problematic” (Bouman & Lukas, 2021). The schematic representation of the analysis is included in Figure 2-1. As opposed to the qualitative judgment, the answer to this question is strongly dependent on the context (how much water is available) and the distribution (is the water available equally distributed to different users).

This is done through a comparison of the proportions used by the different water users. In addition to the volumes that are being currently used, a series is added for the target water use per sector (Bouman & Lukas, 2021.). The series represents the (perceived) missing/excessive amount for that sector. The target amount is determined by stakeholder interviews, literature research for benchmark values, or expert consultation.

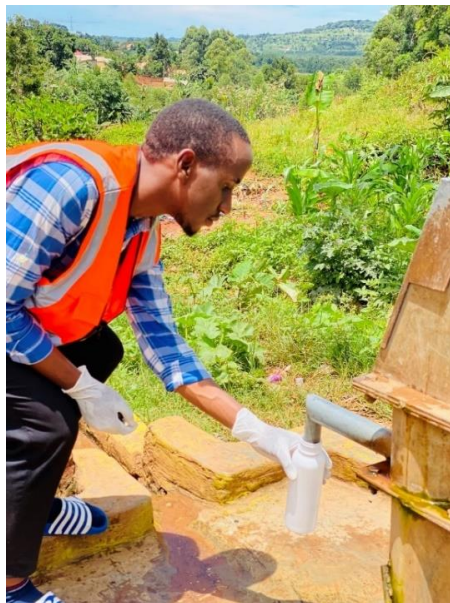
Figure 3-3: Sample Collection at Mawonve Borehole

A Bunsen burner was then used before collecting the water in a container to heat the outlet of the borehole and spring. This was done to kill any form of contamination for example pathogens that would cause inaccuracy in the laboratory analysis. The heating was done for about 10 minutes. With Gloves, the bottle and cap were rinsed three times with sample water and fill the bottle to within one to two inches from the top. Some of the parameters were tested on site using a multi-parameter meter. These were pH, electrical conductivity, and dissolved oxygen. The sampling bottle with the sample were placed into a cooler with ice for immediate delivery to the laboratory. Eight parameters were analyzed from the Directorate of Government Analytical Laboratory under the Ministry of Internal Affairs. The reason for the choice of the parameters and the method of testing is explained in Table 3-4.

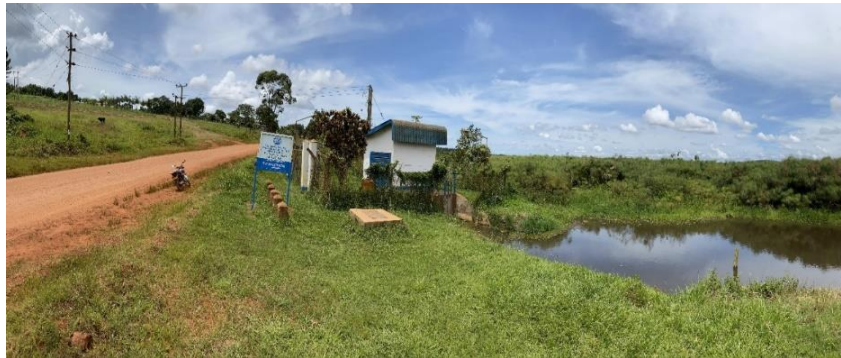
Figure 4-1: Unprotected intake at Kiyanja Swamp

Routine deterioration of the water quality is predominately caused by heavy rains, which wash sediments from the nearby road and increase the turbidity of the swamp water. The decay of the papyrus in the swamp deposits organic matter which is a felt at the treatment process. The Kiyanja swamp is predominantly covered by papyrus and with each day that passes, so many of these plants decay posing a threat to the quality. These overall increases the costs of water treatment in terms of the chemicals need to eliminate pollutants from the water.

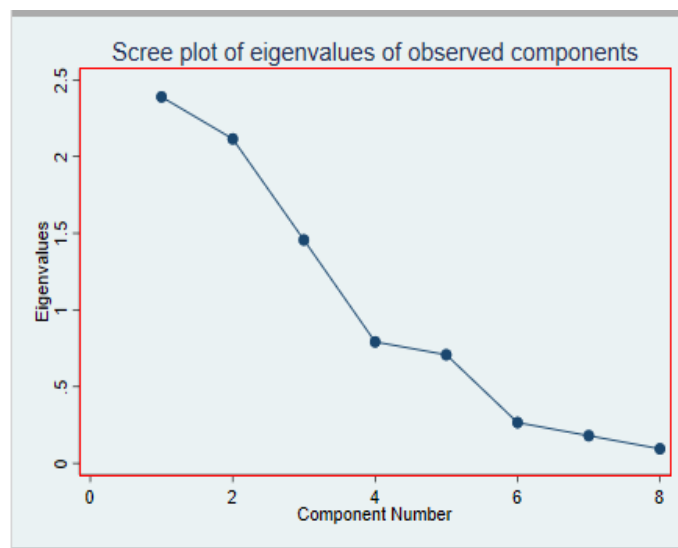
Figure 4-12: Scree plot for eigen values of the observed components

Component	Eigenvalue	Difference	Proportion	Cumulative
Comp1	2.38875	.273501	0.2986	0.2986
Comp2	2.11525	.658962	0.2644	0.5630
Comp3	1.45629	.664457	0.1820	0.7450
Comp4	.791828	.0841937	0.0990	0.8440
Comp5	.707635	.441936	0.0885	0.9325
Comp6	.265699	.0857851	0.0332	0.9657
Comp7	.179914	.0852701	0.0225	0.9882
Comp8	.0946436	.	0.0118	1.0000
